**Flood Control Project Maintenance  
Levee Inspections**

**Fall 2009 Levee Maintenance Deficiency Summary Report**

**Levee Inspection Report By Mile - Fall 2009**

**Sacramento Maintenance Yard Maintenance Area 0004**

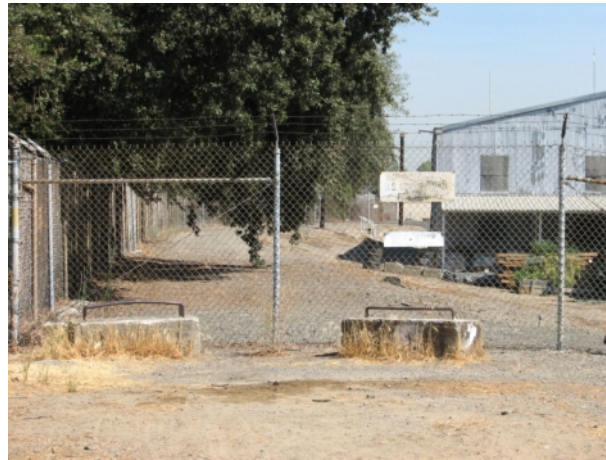
john\_gw\_20090924\_1.jpg

Levee Mile Report Line	1
Start Levee Mile	0.26
End Levee Mile	0.71
Location	Crown
Category	Earthen Levee
Item	Encroachments

Corp. of Engineers fence across levee blocking levee crown

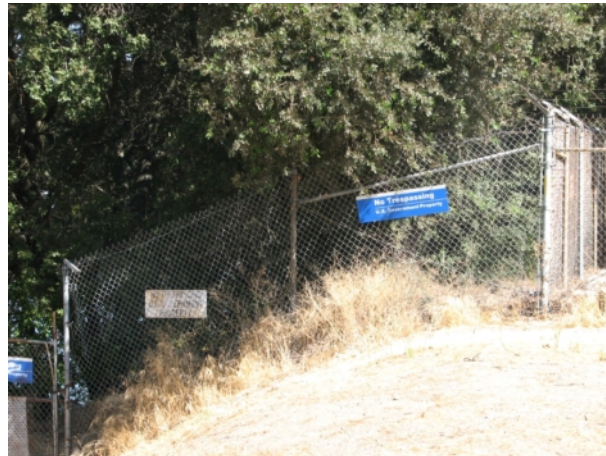
john\_gw\_20090924\_2.jpg

Levee Mile Report Line	1
Start Levee Mile	0.26
End Levee Mile	0.71
Location	Crown
Category	Earthen Levee
Item	Encroachments

Corp of Engineers fence down waterside slope small walk thru gate at toe un able to inspect
